HORSEY WINDPUMP:

Standing still and silent for over 75 years this iconic Norfolk Broads building was brought back to life through expert craftsmanship. Architect and SPAB Scholar, Philip Orchard writes.

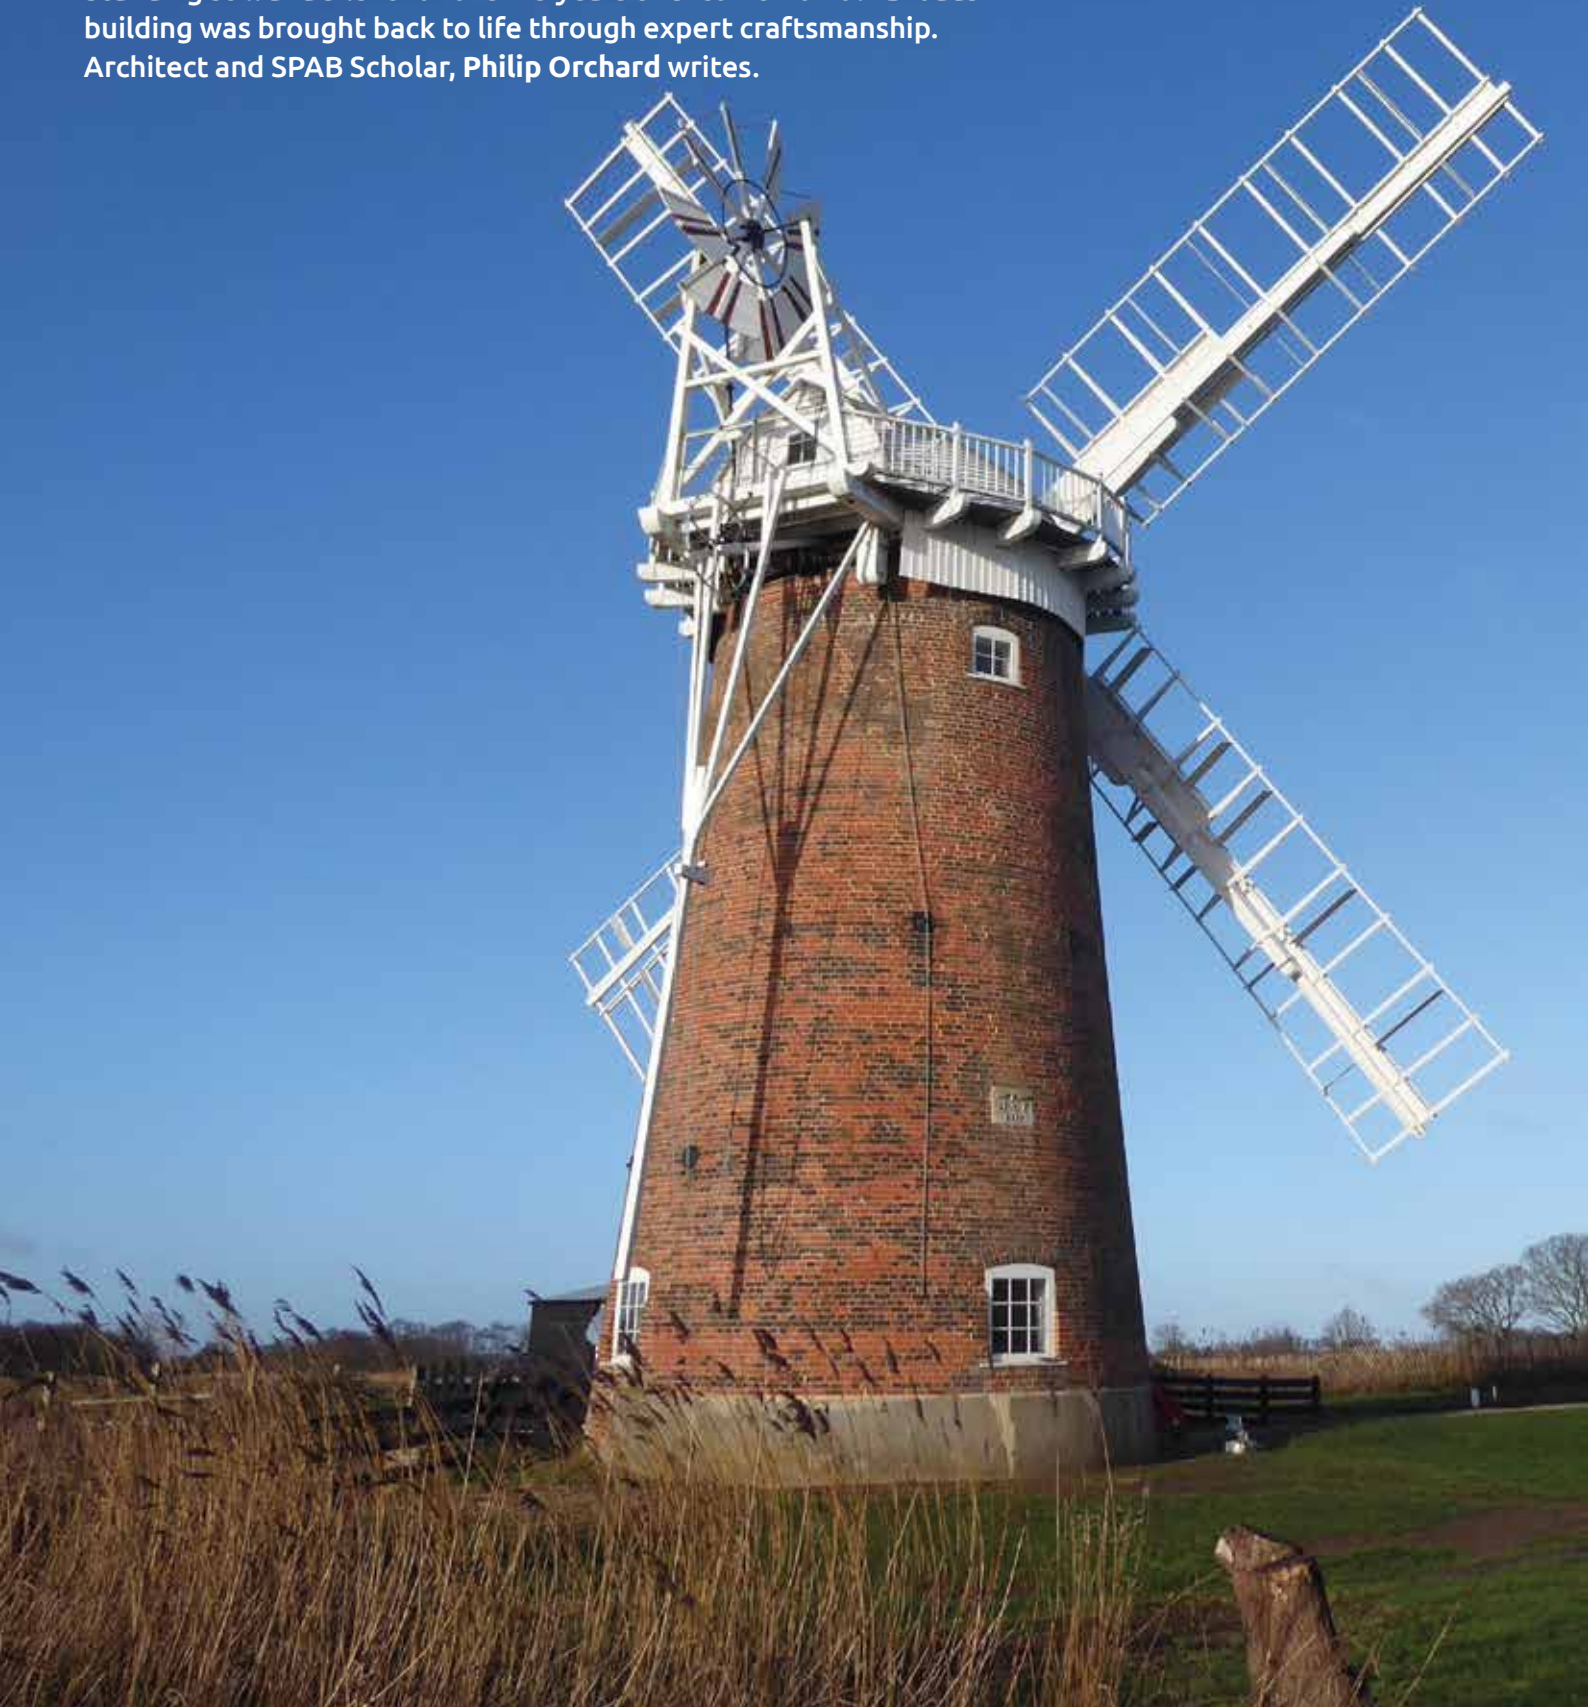
Left Horsey Windpump after repair.

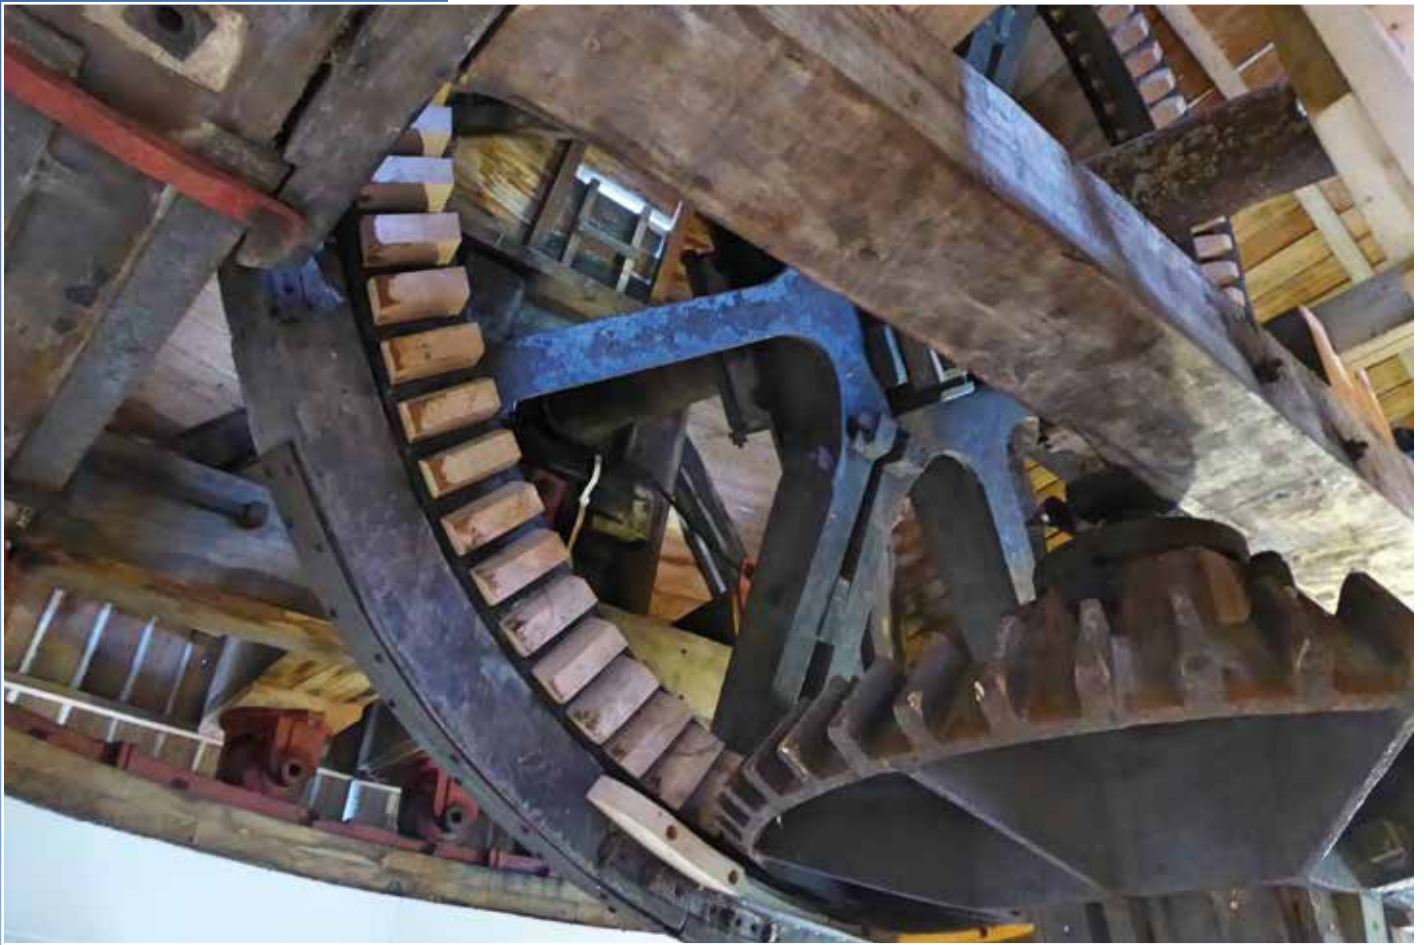
Above Horsey Windpump is now working for the first time since 1943.

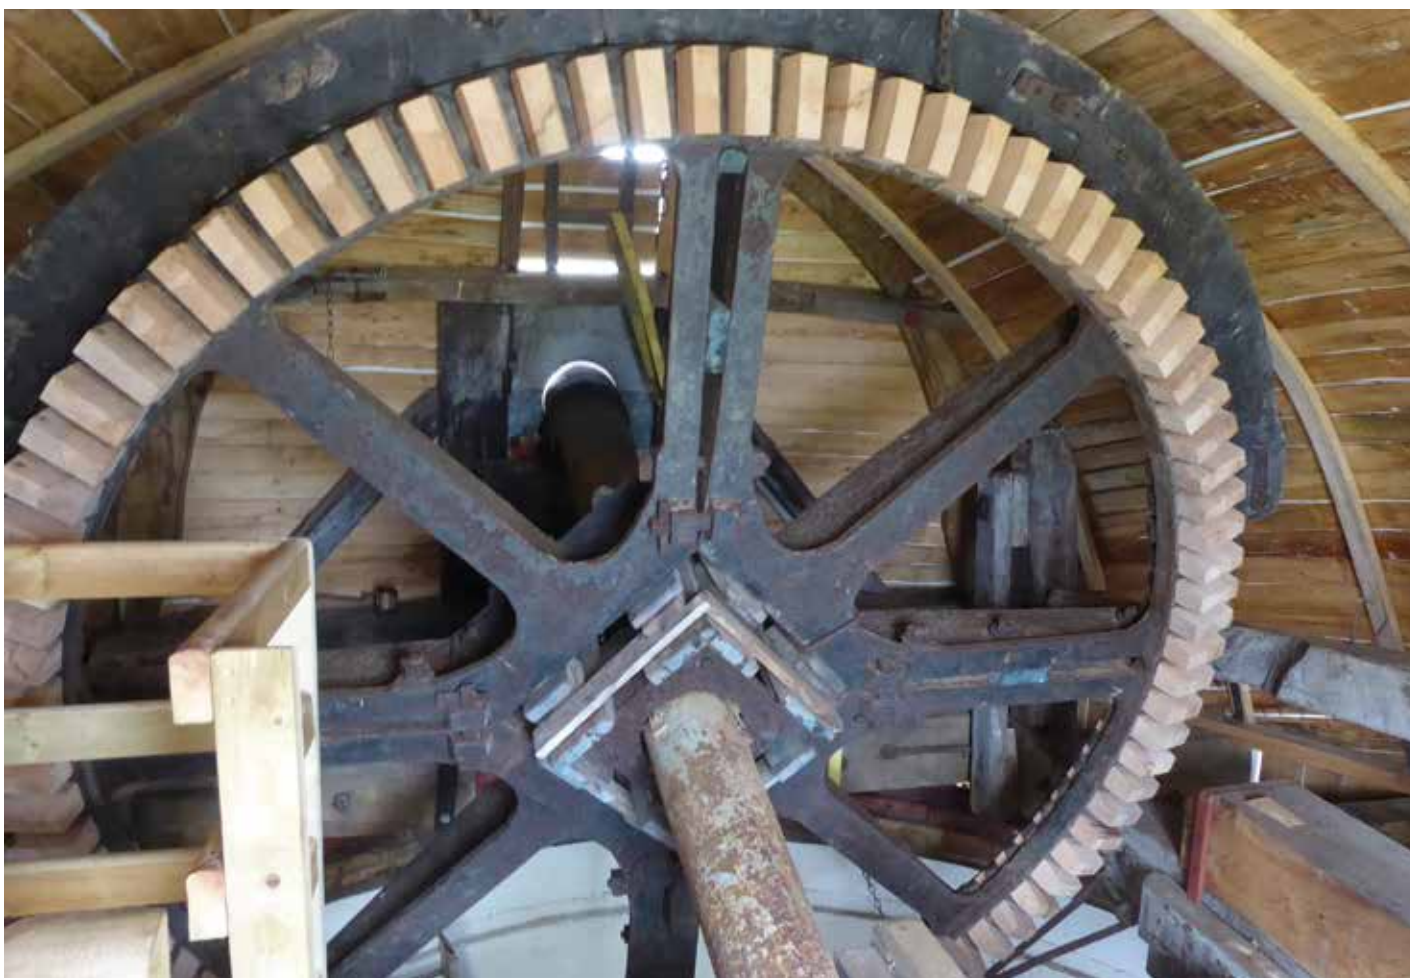
Above The National Trust has adopted an approach of ‘conservative repair’ that has retained as many of the windpump’s components as possible.

The National Trust's long-term ambition was to have a fully functioning drainage windpump. The expectation has been that every part of the windpump, working or static, should be retained where it was still fit for its purpose and that no parts should be rejected purely based on age or appearance. The approach was to carry out 'conservative repair' as far as a working machine will allow.
